# NBS SPECIAL PUBLICATION 592

## An Investigation of the Miyagi-ken-oki, Japan, Earthquake of June 12, 1978

On June 12, 1978, a destructive earthquake with Richter magnitude of 7.4 occurred off the east coast of Miyagi Prefecture, Japan. Preliminary estimates by the National Land Agency of Japan indicated that the earthquake caused an equivalent of \$800 million in total damage. There is a cooperative agreement between the governments of the United States and Japan termed the U.S.-Japan Program in Natural Resources (UJNR). Following the earthquake, it was arranged through UJNR that teams of U.S. structural engineers and geologists would visit Miyagi Prefecture and inspect the damage caused by the earthquake. This report assembles the information and collective experiences of the investigation team so as to describe the earthquake and document its effects. Field investigations conducted by geologists and structural engineers are described in detail and some of the implications for seismic resistant design and construction of structures in the United States are also discussed.

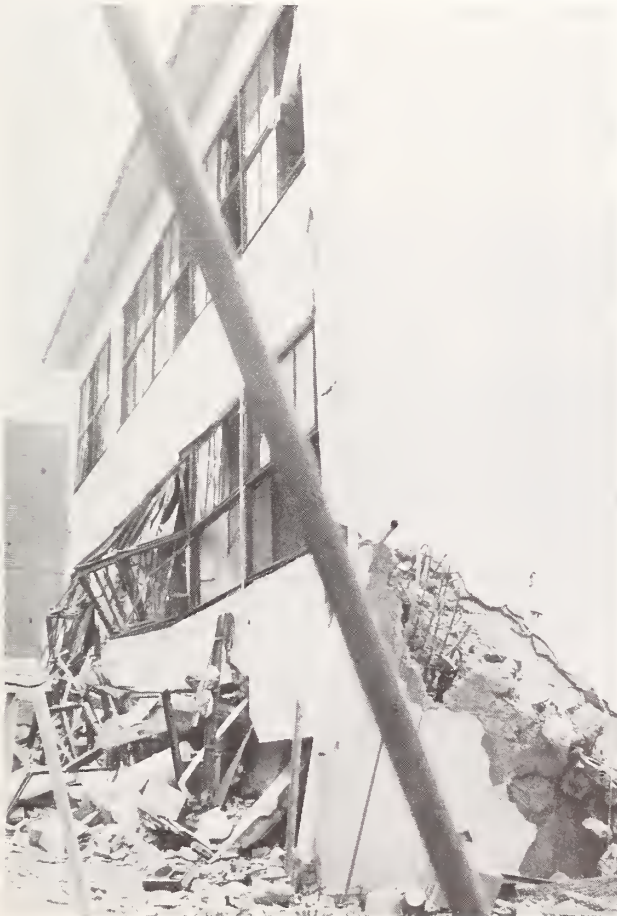
Figure 5.49 Paloma Building, west face.

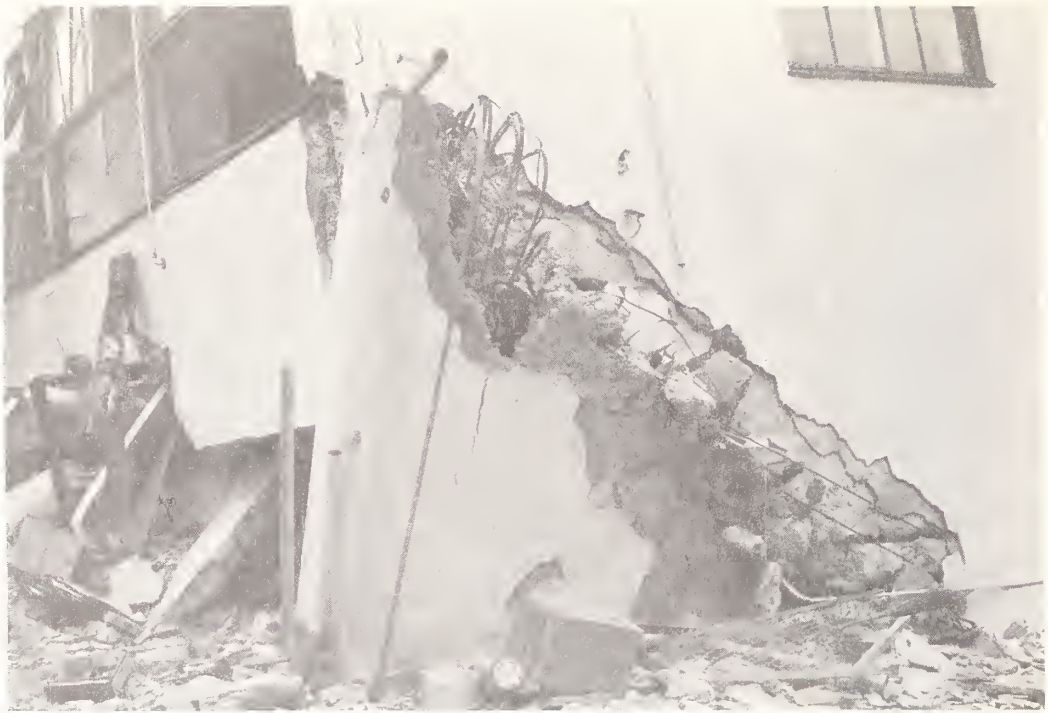
Figure 5.50 Paloma Building, detail of shear wall on west end of building.

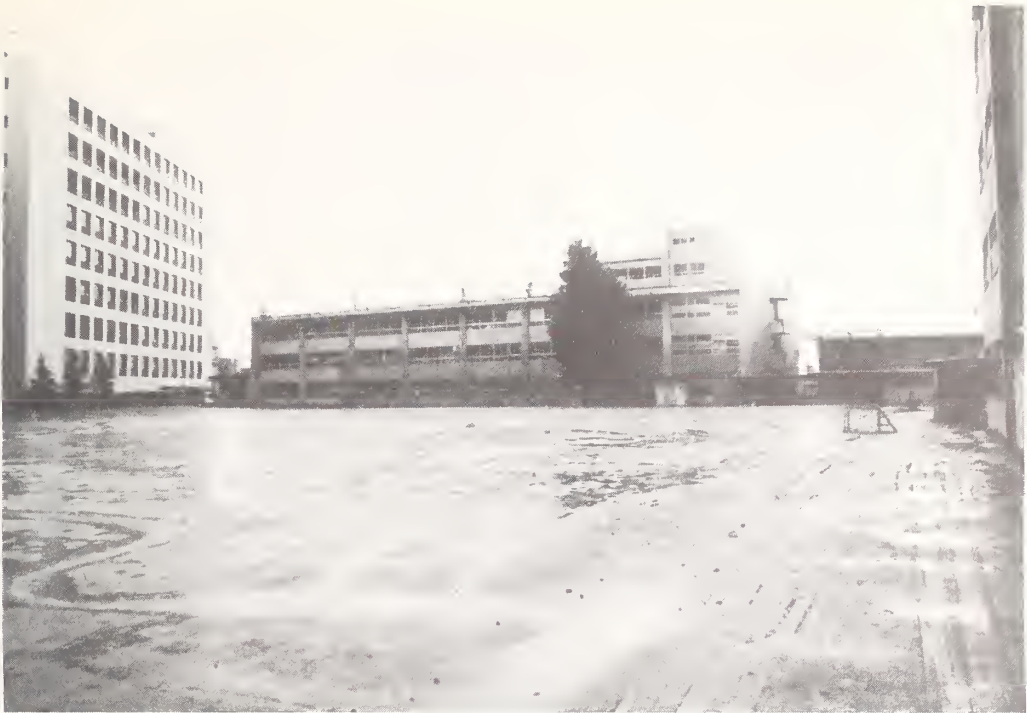
Much of the damage at Tonan High School may be attributed to the unfavorable orientation of the shear walls with respect to the direction of strongest shaking (N-S). A building adjacent to the school but oriented perpendicular to it, which was constructed about the same time and in which the shear walls run in the N-S direction, was undamaged, aside from a few broken windows.

Figure 5.53 Tonan High School, west face. A small bluff on the opposite side of the building may have amplified ground motion. The adjacent structures were undamaged.

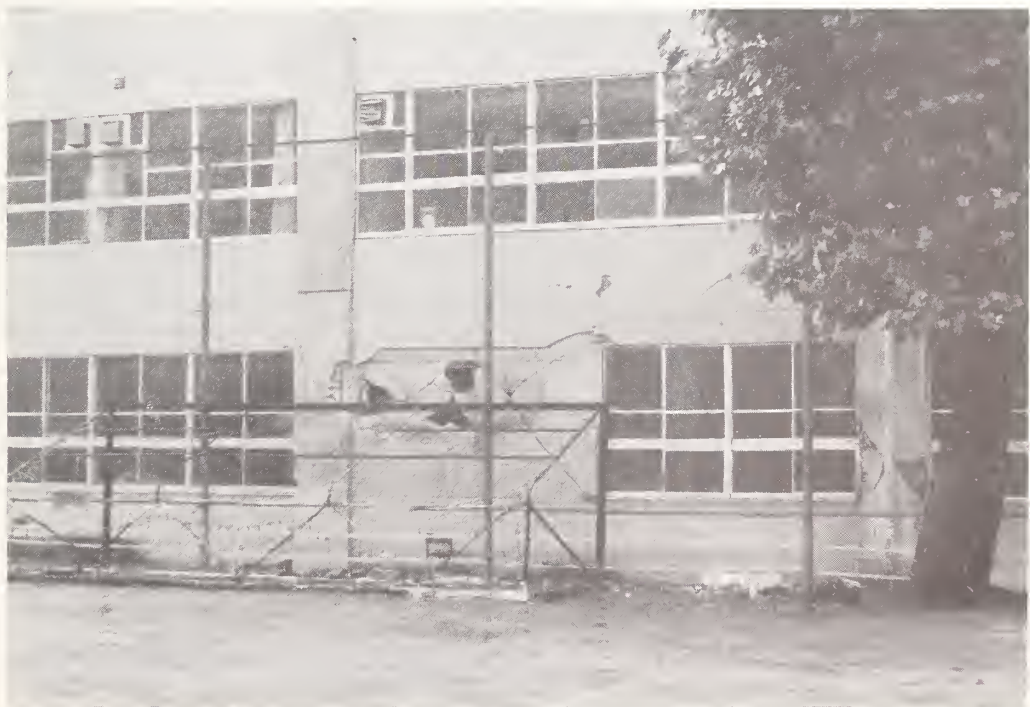
Figure 5.54 Tonan High School - Detail of damage to west face.

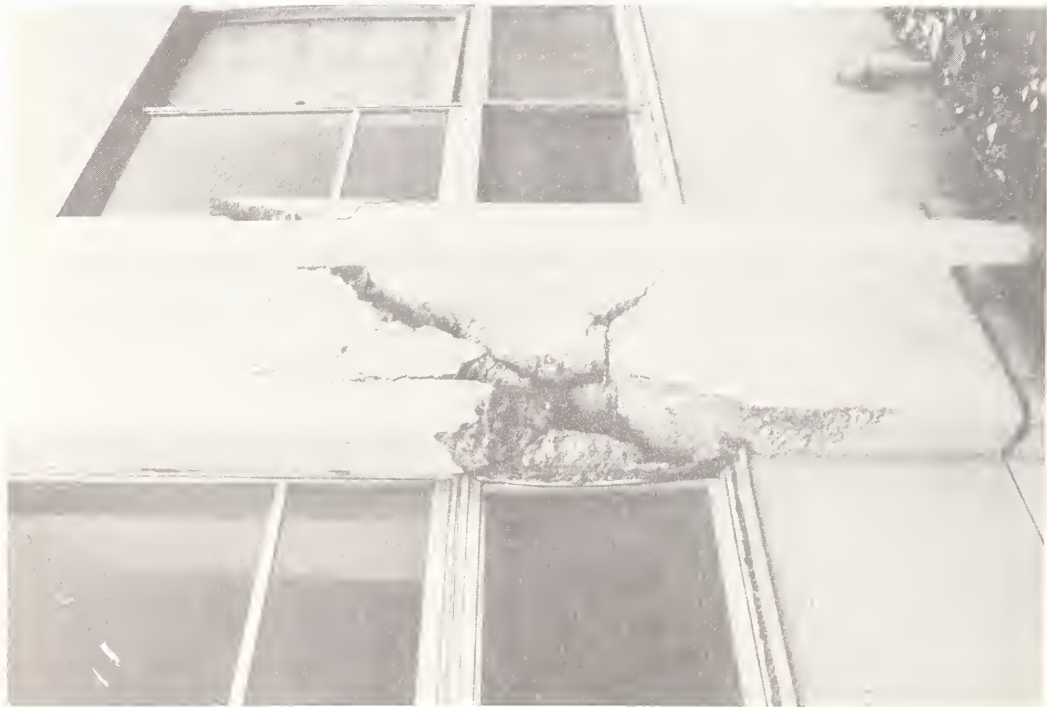
The west face elevation and the school yard are shown in Figures 5.53 and 5.54. The exterior first-story columns were all severely damaged, the shear cracks occurring just above the infill panels, (Figures 5.55 and 5.56). In many cases the width of the cracks was over 20 mm. The upper story columns showed less shear cracking. The interior columns did not appear to be damaged. They lacked the stiffening provided by the infill panels. A corridor ran along the length of the building in the middle, and the shear walls were not continuous across the width of the building. Undeformed reinforcing bars were used in the columns. The ties in the exterior columns were spaced at roughly one-half the maximum dimension of the column.

Figure 5.55 Tonan High School. Detail of shear cracking in exterior column above partial infill panels on east face

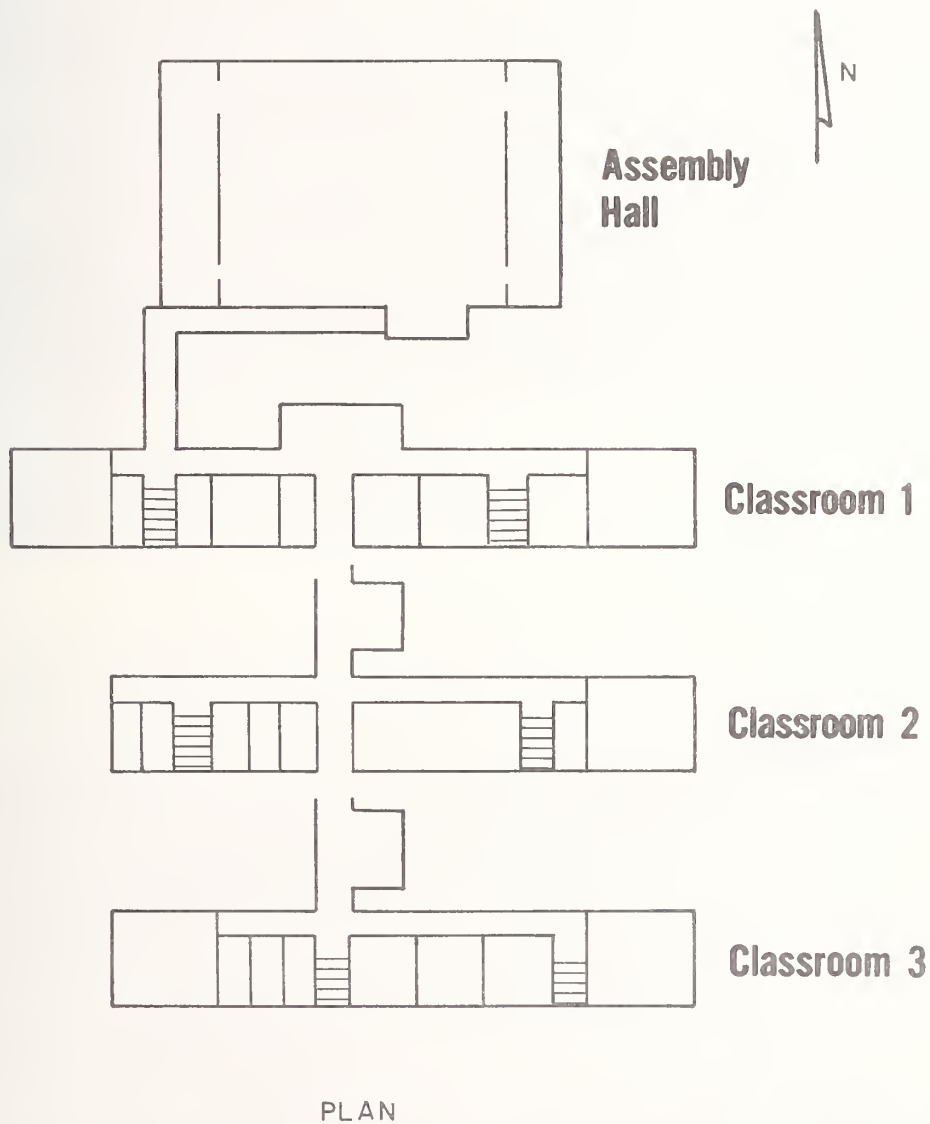
Note from Figure 5.57 that the interior shear walls do not run the width of the building, as they are interrupted by the corridor on the north side of the building. The cracking was less severe on the open side of the building, where the shear walls connect to the columns.

Figure 5.57 Izumi High School, Izumi City. Plan view of steel frame assembly hall and three reinforced concrete classroom buildings.

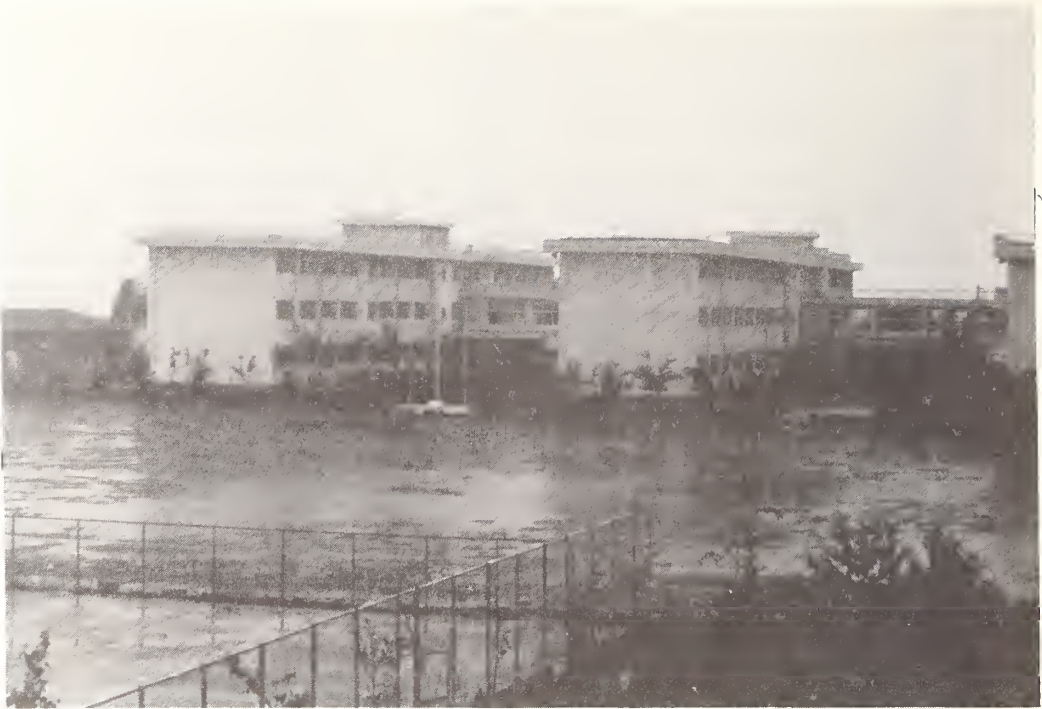
Figure 5.58 Izumi High School. Three adjacent reinforced concrete frame buildings with shearwalls suffered minor damage.

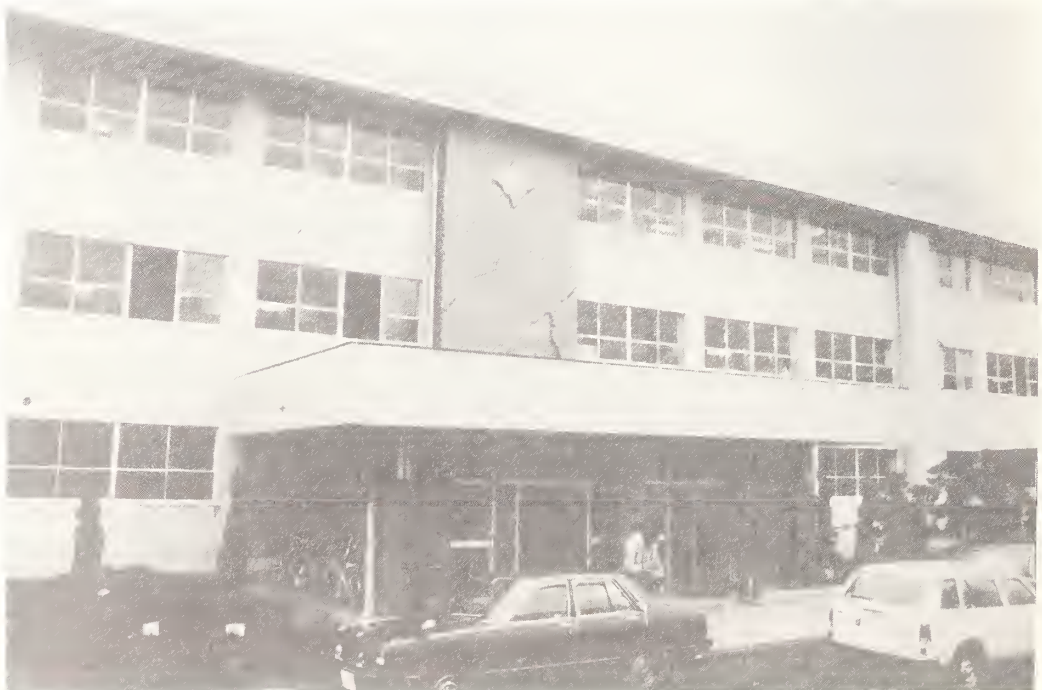
Figure 5.58 shows the east elevation of the three classroom buildings, and Figure 5.59 shows the front entrance on the north side of building 1. The badly cracked panel above the entrance is not connected to the ground floor. The interior corridor walls in the building had extensive diagonal cracks, as shown in Figure 5.60. Figure 5.61 shows the northeast corner of building 2 along the foundation. The diagonal crack at the corner of the exterior wall indicates that either uplifting or settlement of the foundation took place. Figures 5.62 and 5.63 show typical damage on the north and south sides of one of the classroom buildings. Damage was relatively greater on the north side of the building where the columns were stiffened by the infill panels. Although there were numerous diagonal cracks emanating from window openings on the north side, the main columns did not appear to be badly cracked.

Figure 5.59 Izumi High School. Detail of panel over north entrance to building 1.

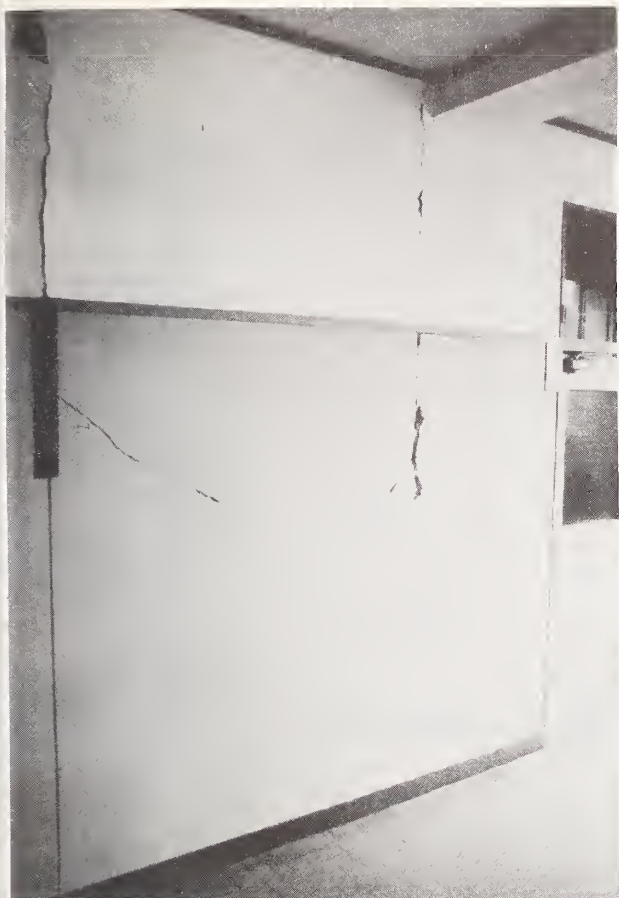
Figure 5.60 Izumi High School. An interior corridor wall in classroom building 1 aligned in the longitudinal direction of the building.

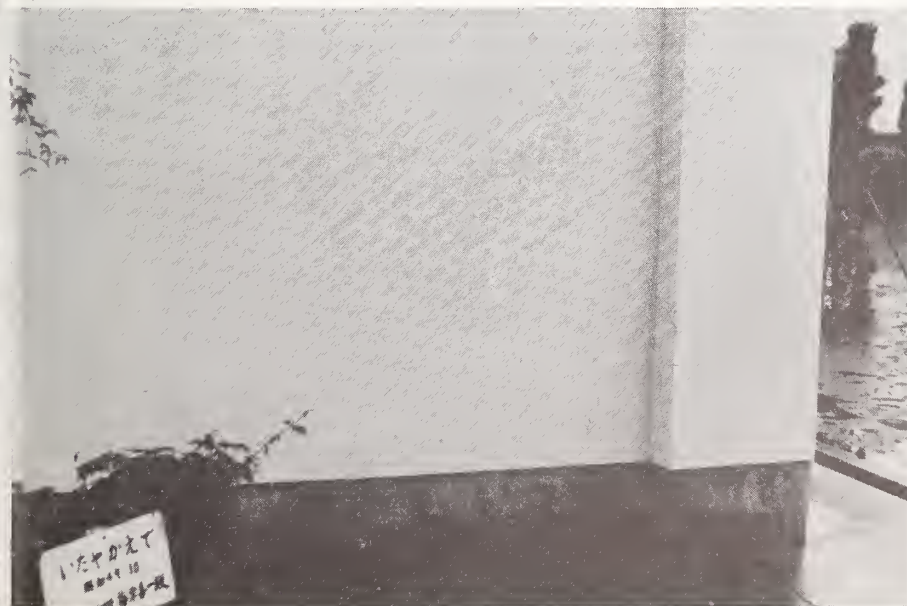
Figure 6.61 Izumi High School. The diagonal crack in the exterior wall shows that foundation settlement or uplift took place at the corner.

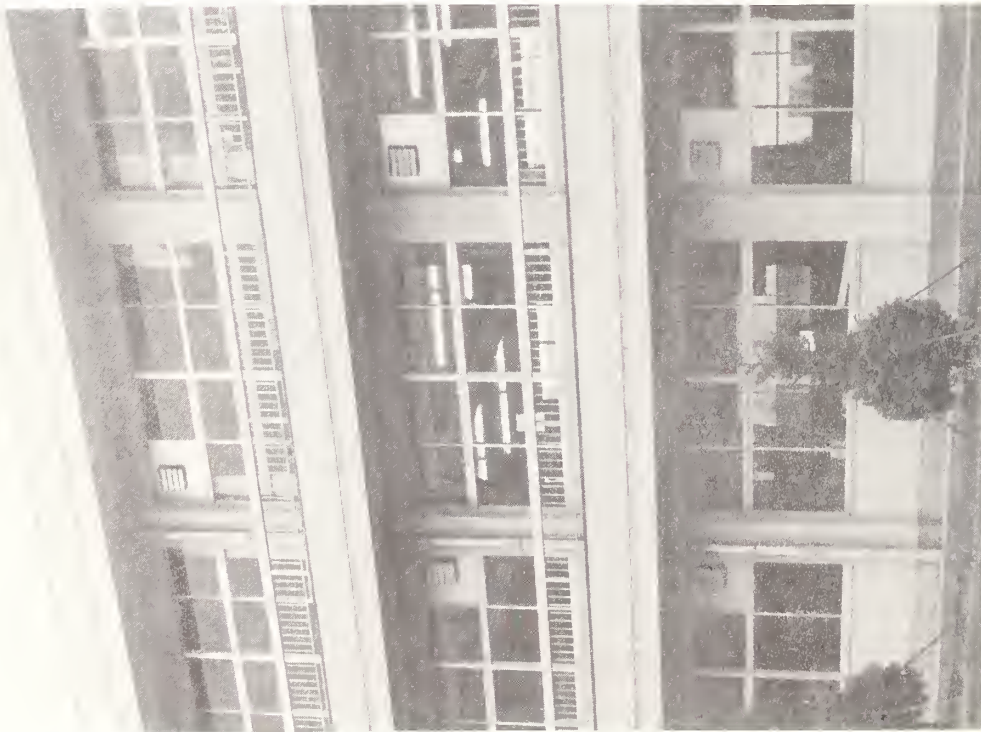
Figure 5.62 Izumi High School, typical classroom building, south face. This side of the building, which is relatively open, suffered little damage.

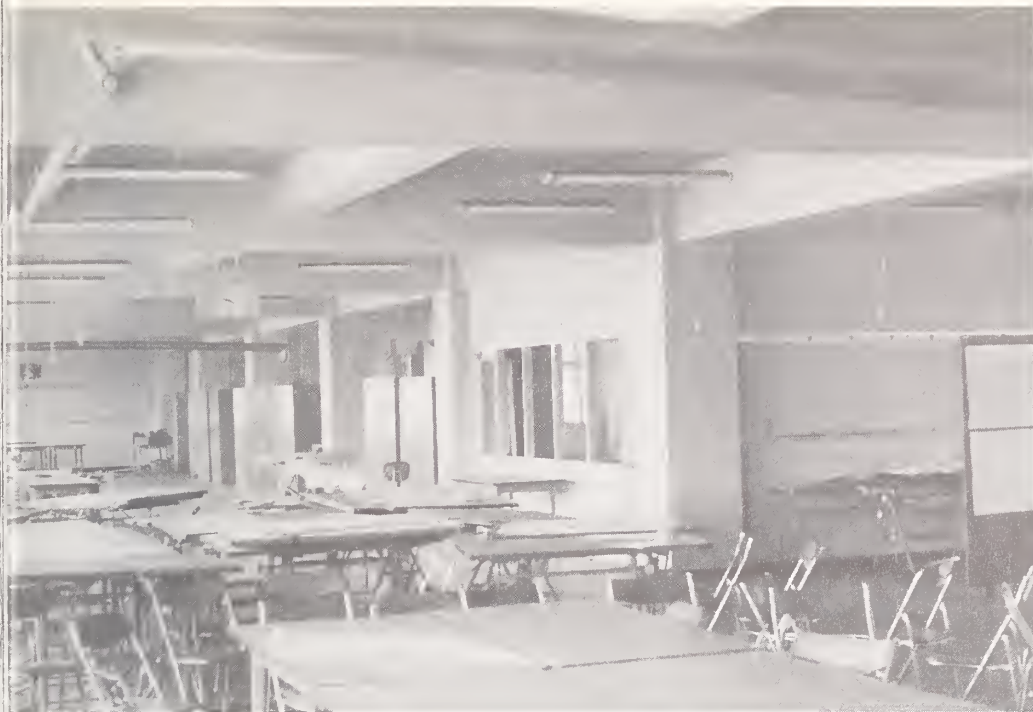
Figure 5.69 Tohoku Institute of Technology, Building 5. Seventh story interior, looking towards the lightly damaged southern exterior frame.

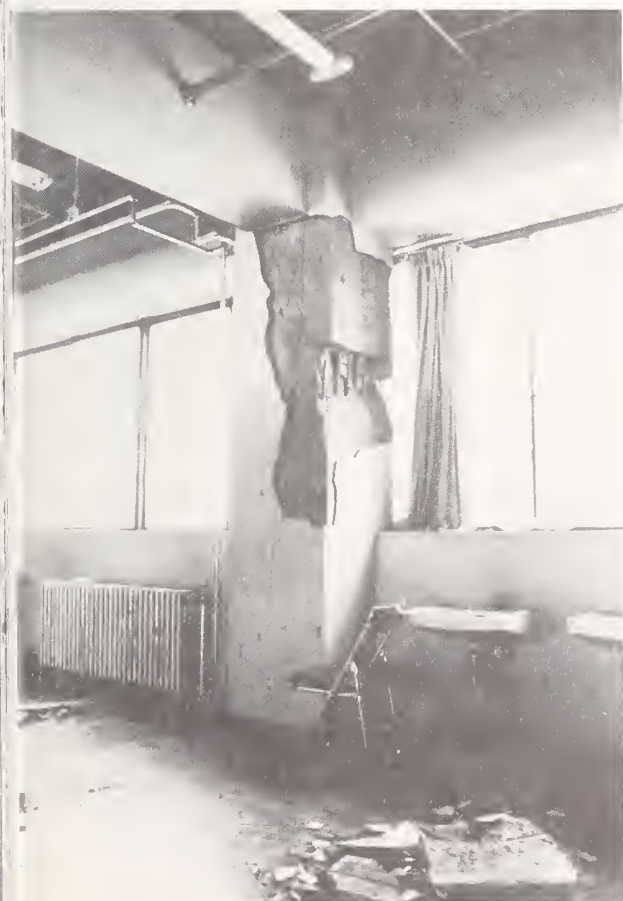
Figure 5.70 Tohoku Institute of Technology, Building 5. Damage to column on north side of third story. The tie spacing is 25 cm.

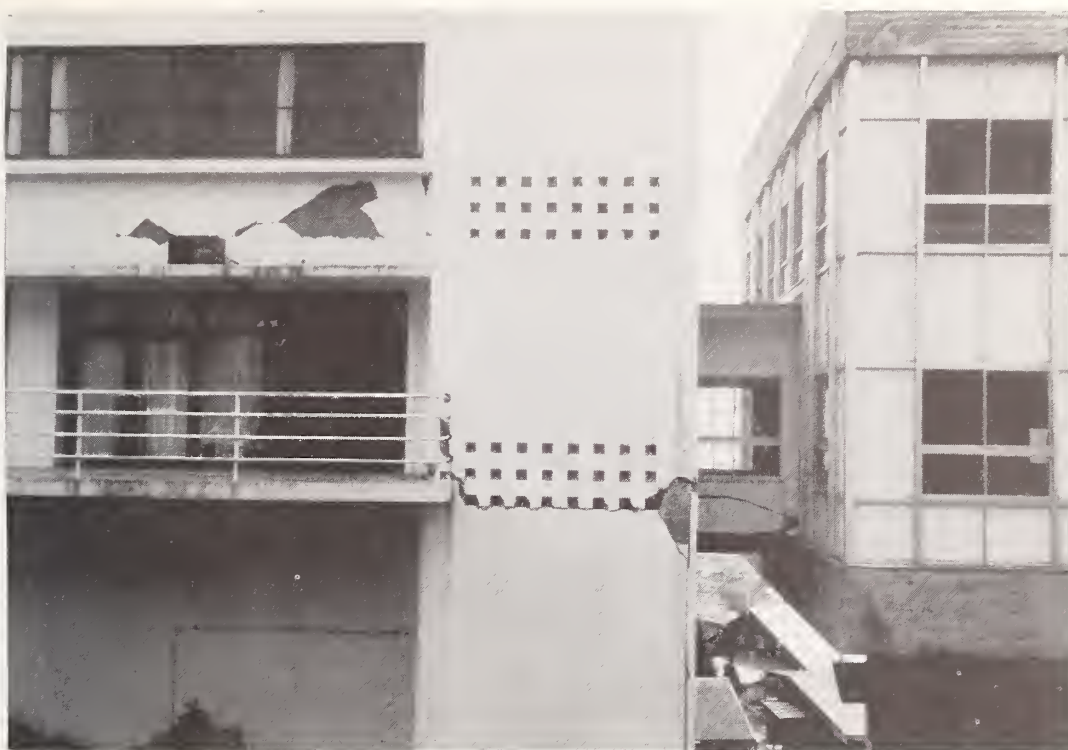
Figure 5.73 Tohoku Institute of Technology. Passage between Building 5 and the building to its west.

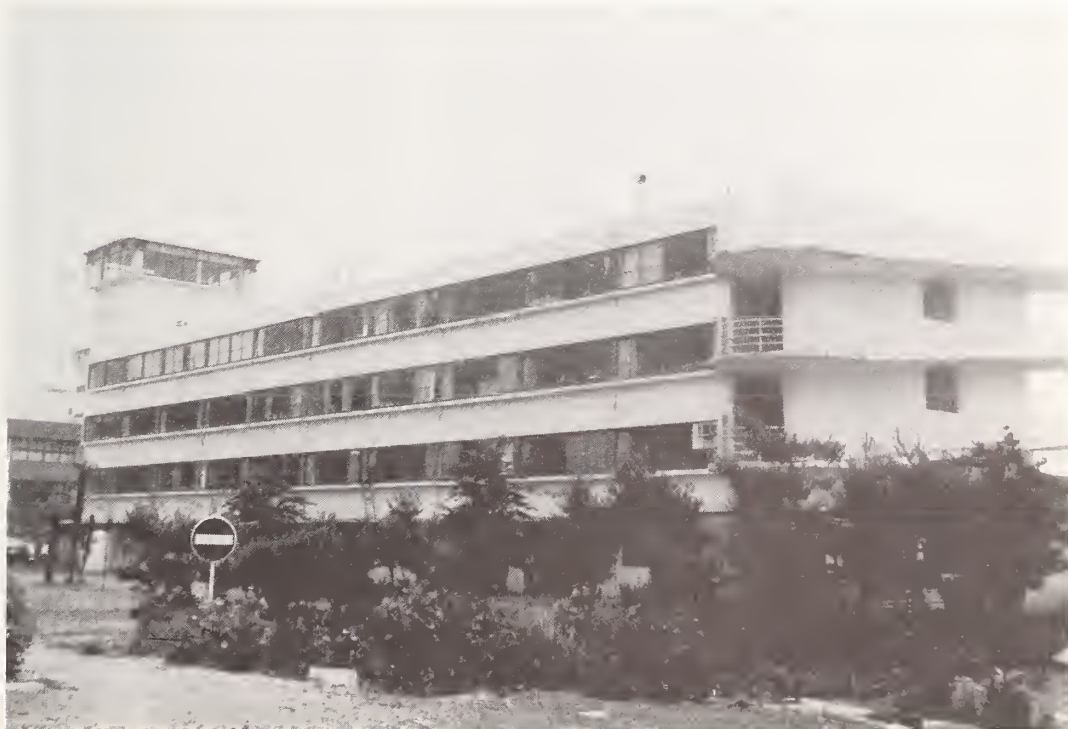
Figure 5.74 Tohoku Institute of Technology, Building 3. General view of the north elevation.

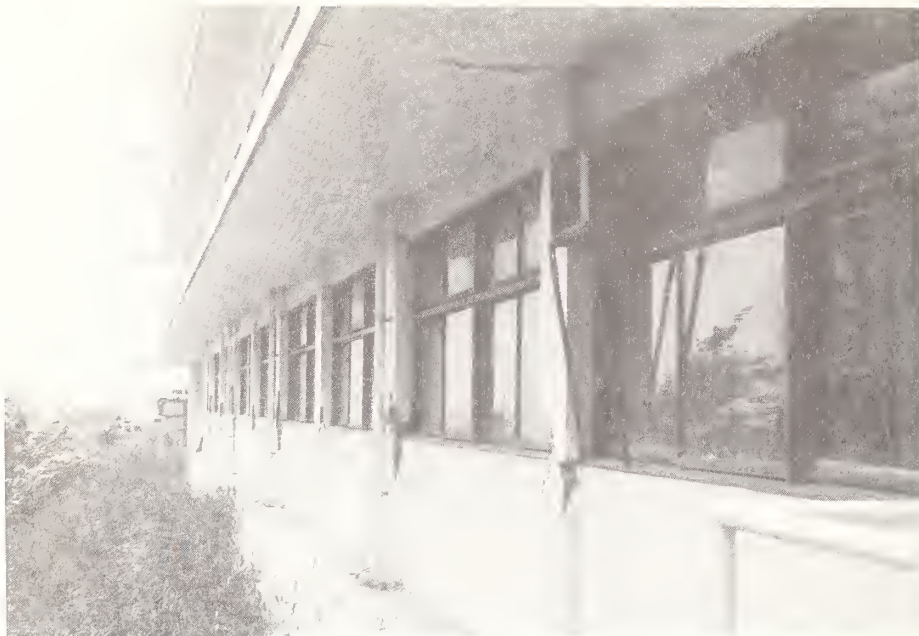
The northeast facade of building 3 is shown in Figure 5.74. This is a four-story reinforced concrete frame building, ten spans by two. While the relatively flexible interior columns were undamaged, all of the exterior columns on the first-story cracked in shear just above the infill panels, as shown in Figure 5.75. Figure 5.76 illustrates this more clearly at one of the first-story columns on the northeast side of building 3. As can be seen, the reinforcement is undeformed. We were informed that core samples taken out of the spandrels showed no apparent damage to the concrete.

Figure 5.75 Tohoku Institute of Technology, Building 3. Damage to the ground floor columns on the south side of the building. Similar damage is present on the opposite side of the building.

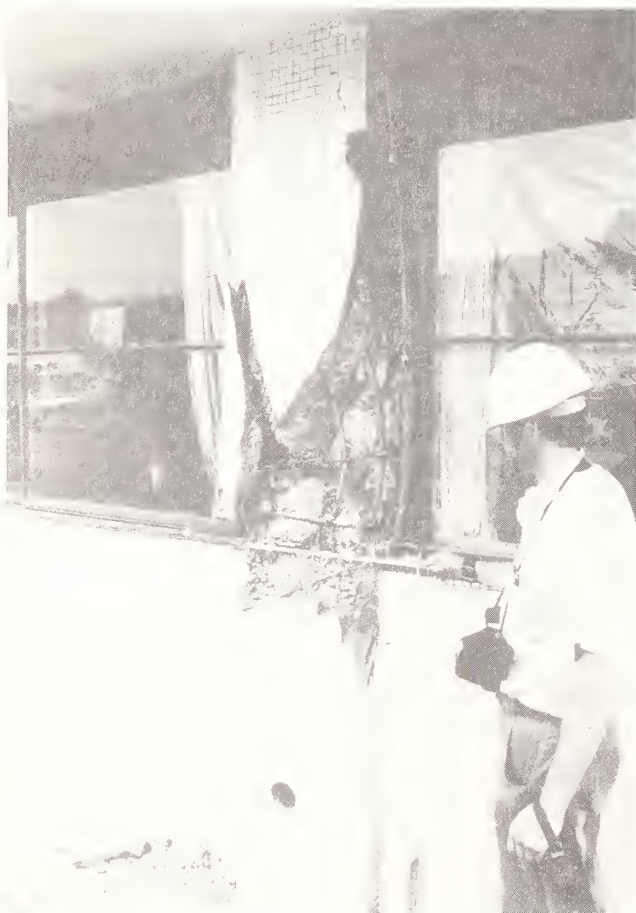
Figure 5.76 Tohoku Institute of Technology, Building 3. Typical damage to ground story exterior column on north side of building.

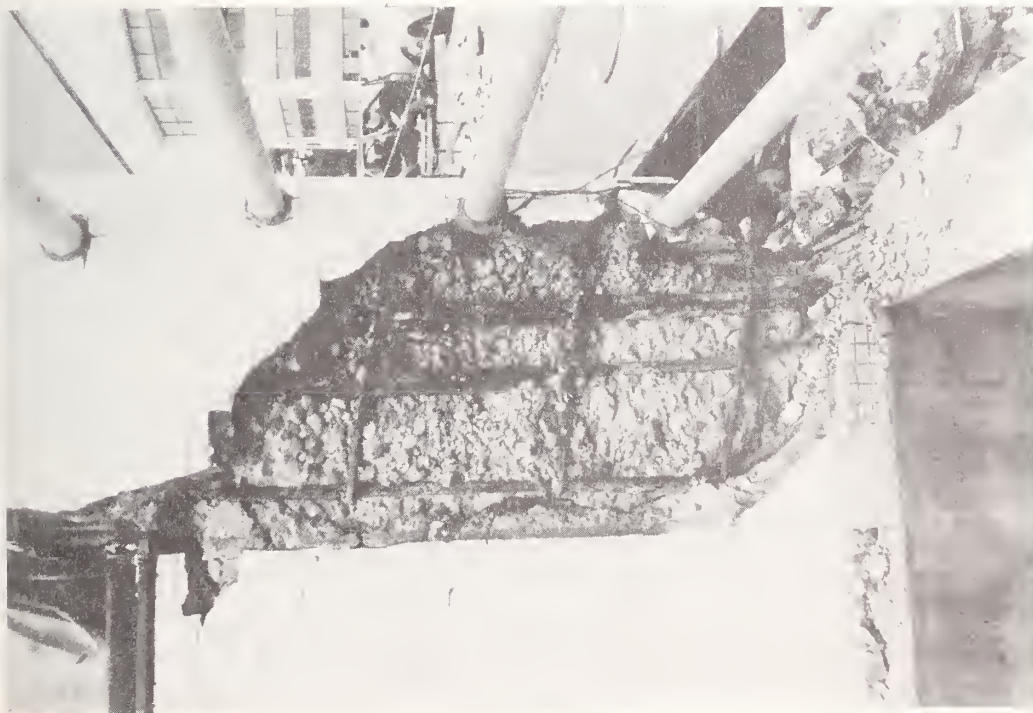
Around the entrance on the east side of building 3 and the southeast corner of its first-story, large areas of the tile facing and concrete underneath had spalled off, exposing the reinforcement (Figure 5.77). At this location, the vertical reinforcing bars were bent manually during construction in order to force them to conform to the building working drawings. The reinforcement appeared to have less than 10 mm concrete cover. The interior walls of building 3 showed extensive diagonal cracking (Figure 5.78). However the interior columns were apparently not damaged.

Figure 5.77 Tohoku Institute of Technology, Building 3. Detail of one of the damaged columns of the exterior frame on the south side of the building showing reinforcing details.

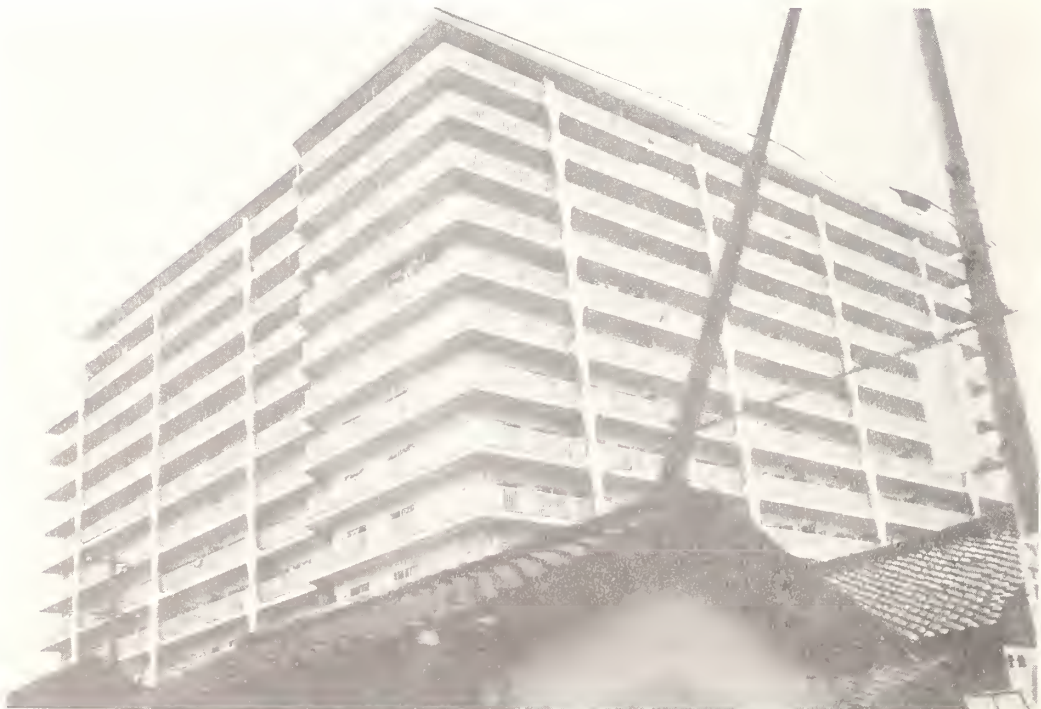
Figure 5.81 Sunny Heights Apartment Building, Sendai. General view from the southwest.

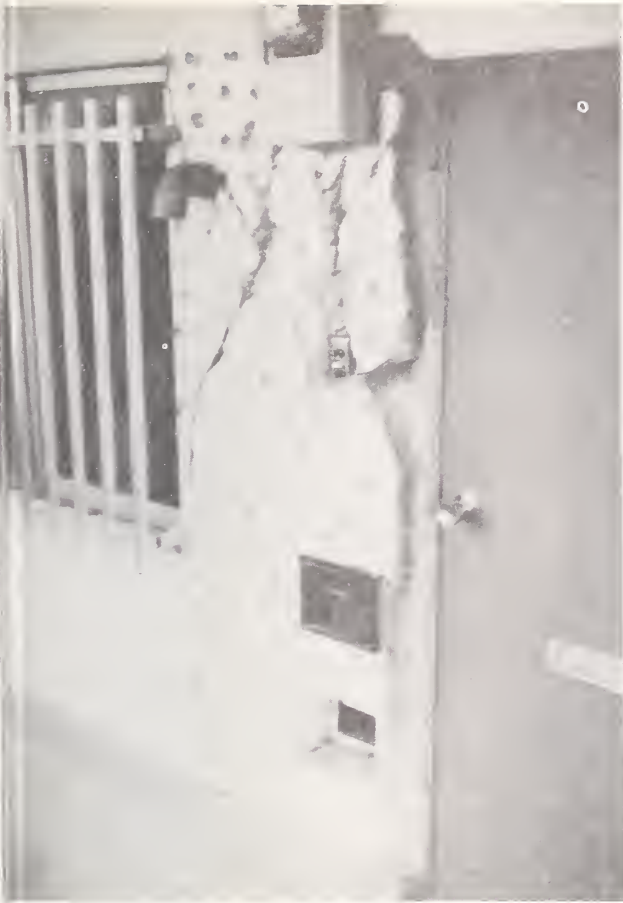
Figure 5.82 Sunny Heights Apartment Building. Detail of cracking of panels adjacent to doorways. Such cracking was typical at all levels on the east facade of the structure.

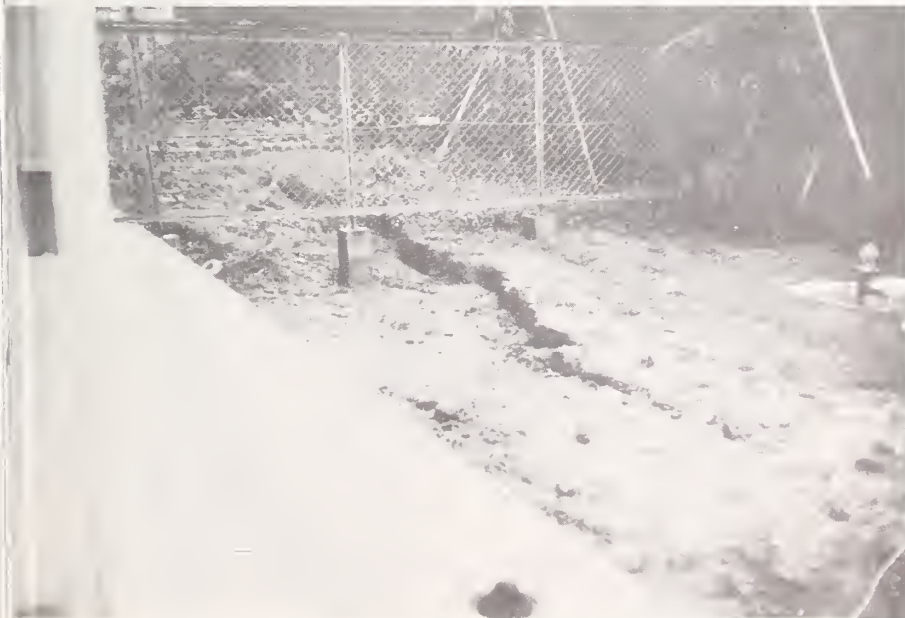
There was extensive evidence of ground cracking and settlement adjacent to the foundation and the walkway surrounding the building, as can be seen in Figure 5.83, where the support post below the bottom rail of the fence is exposed. The ground adjacent to the foundation subsided several inches in some cases. Portions of the parking area around the building appeared to have settled about 18 in (460 mm). There was a large water shortage tank located on top of the roof. It was shaken loose from its anchorage when the anchor bolts failed and the horizontal movement also caused the supply pipe to be damaged.

Figure 5.83 Sunny Heights Apartment Building. Ground cracking and settlement adjacent to walkway surrounding the building.

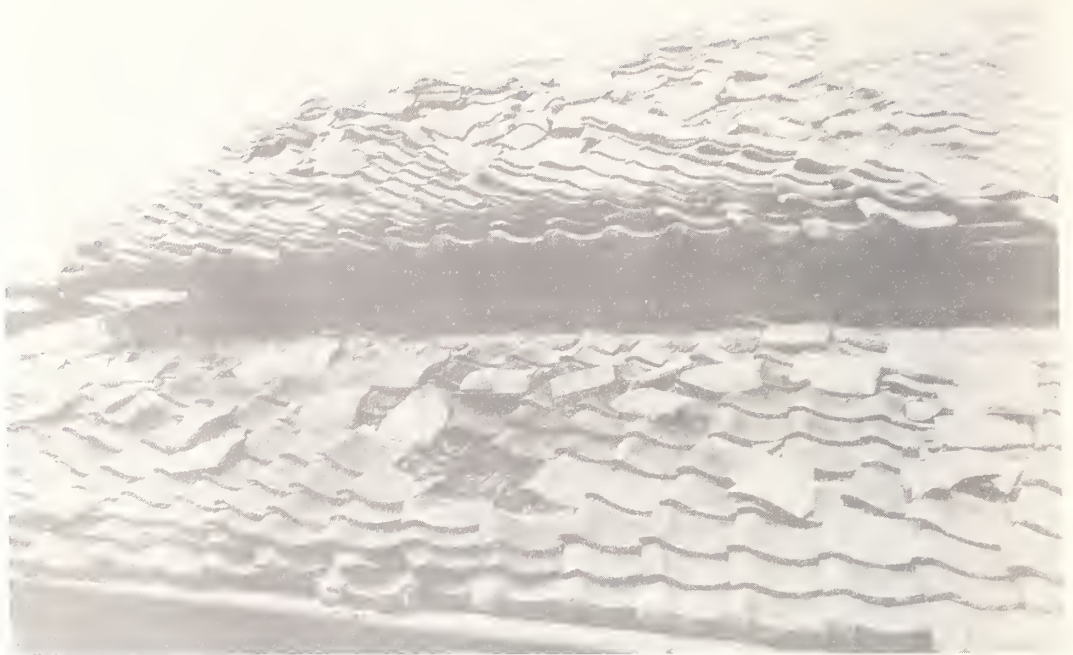
from the remainder of the structure due to ground settlement. There were many instances where tile roofs were badly damaged even when the structure remained standing (Figure 5.86).

Figure 5.86 Typical damage to tile roofs in Sendai (Japan National Land Agency photograph)

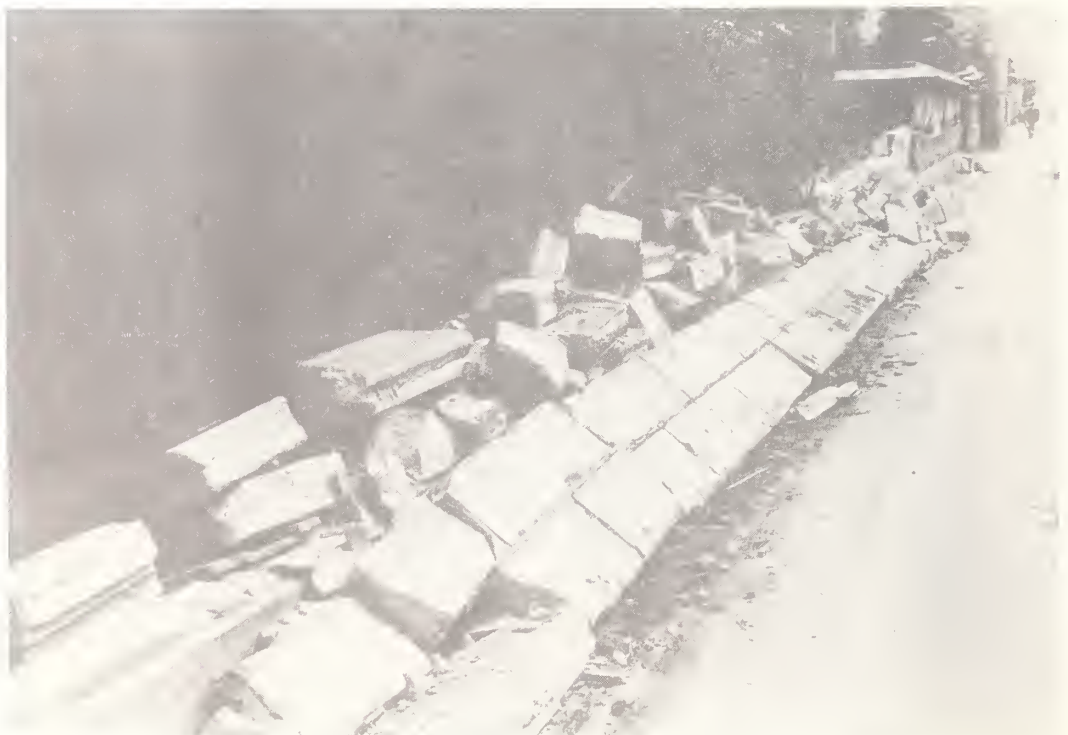
Two examples of collapsed masonry-unit walls are shown in Figures 5.87 and 5.88. The wall shown in Figure 5.87 was not reinforced, and crumbled during the earthquake. The wall in Figure 5.88 contained reinforcement but was not anchored adequately to its foundation and toppled over practically as a unit.

Figure 5.87 Failure of unreinforced concrete masonry wall in Sendai (Japan National Land Agency photograph)

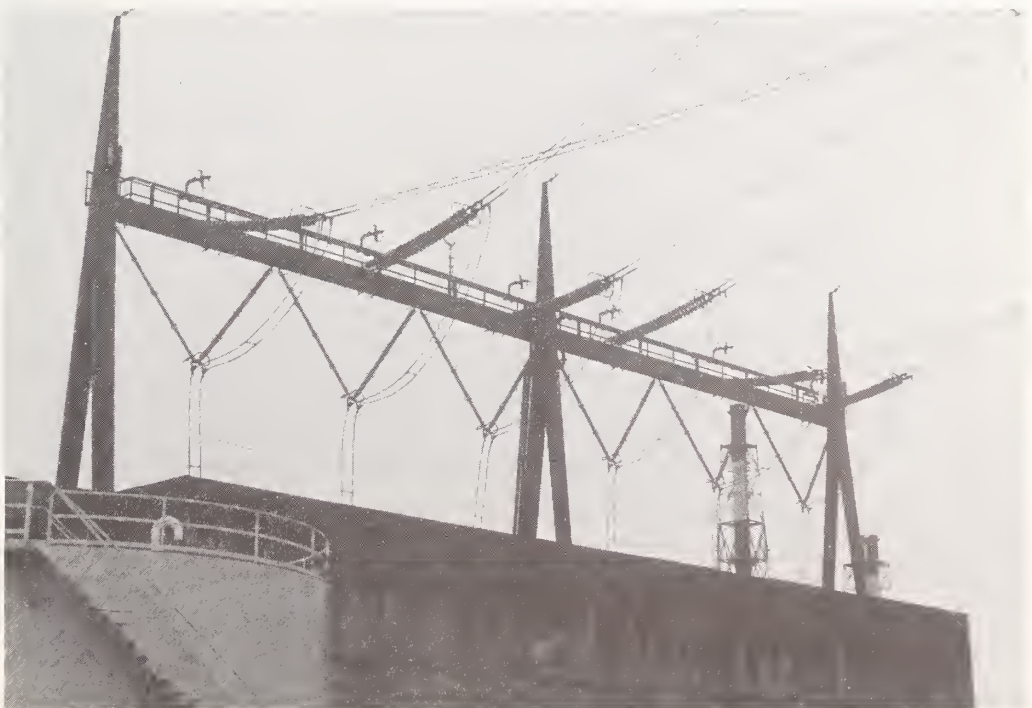
Figure 6.10 Fukushima Nuclear Power Plant. Broken ceramic insulators were the only damage reported for the site. The damaged insulators had been replaced, as illustrated above, within hours after the earthquake and before the reconnaissance visit.

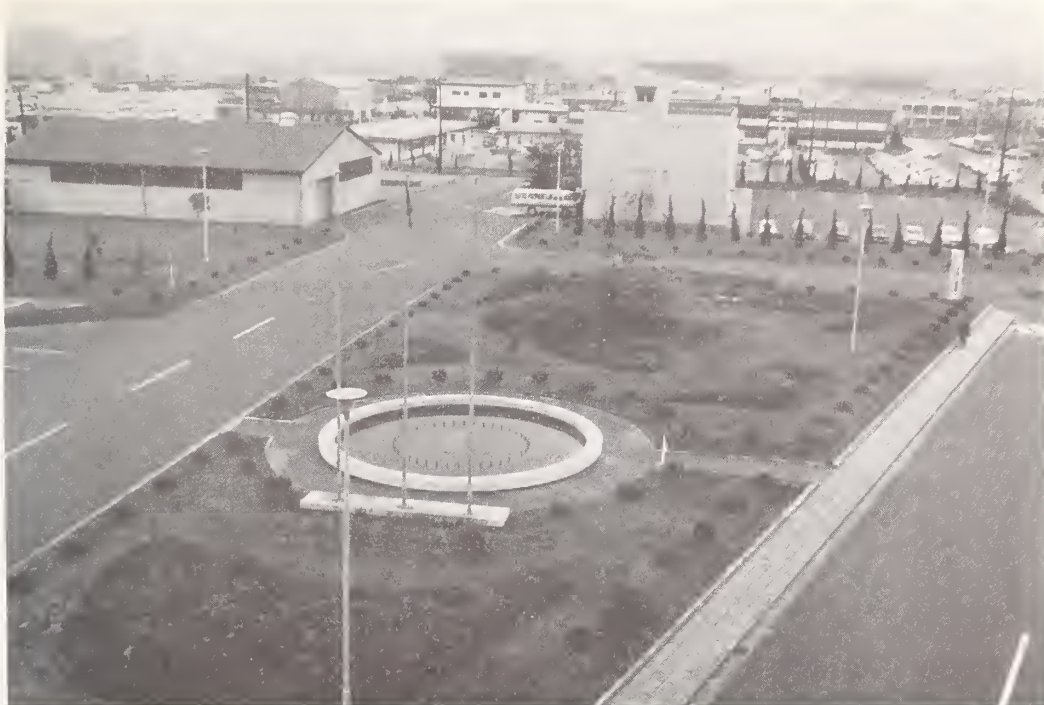
Figure 6.14 New Sendai Power Plant; Tohoku Electric Power Company: A view of the entrance area to the power plant showing settlement of fill and subsequent repair work to the pavement. The pavement settled approximately 15 cm (6 in) and was primarily in the vicinity of a backfilled underground pipeline.

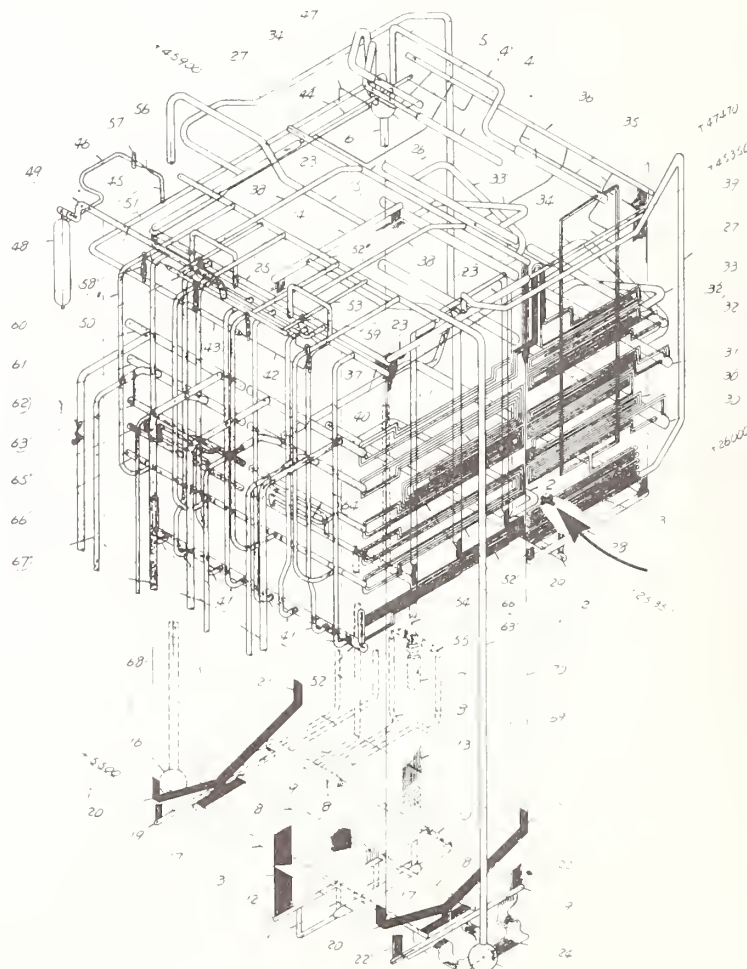
Figure 6.17 New Sendai Power Plant, Tohoku Electric Power Company. The arrow points to the location of the damaged horizontal spacer tubes in the 600-MW boiler of Unit No. 2. (See Figure 6.18).

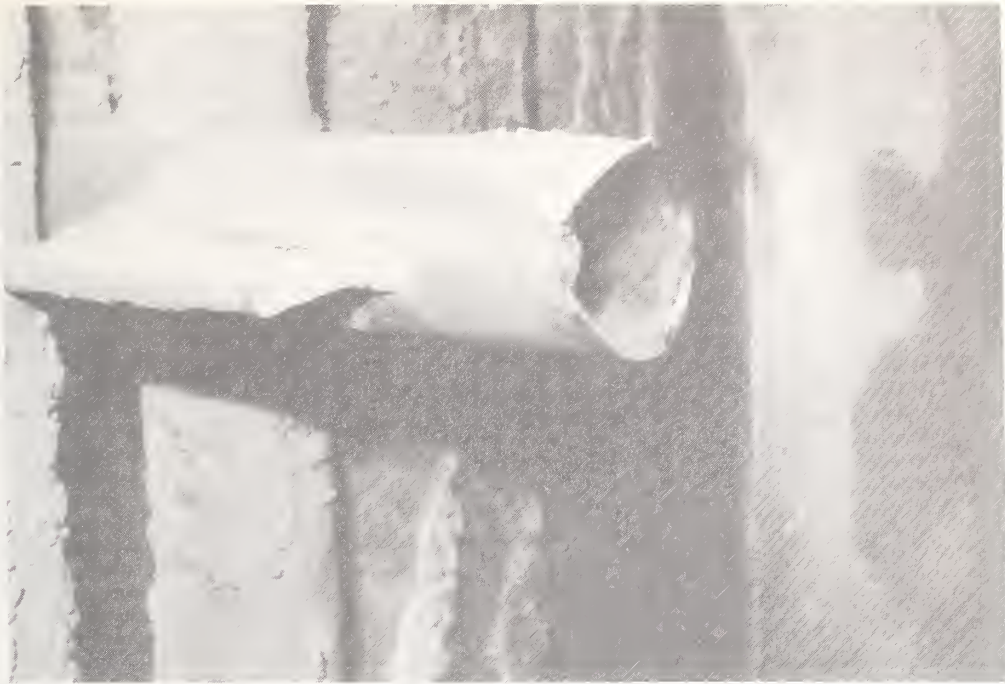
Figure 6.18 New Sendai Power Plant, Tohoku Electric Power Company: damage to the two boilers consisted of shearing of spacer tubes for the furnace platen cooler tubes inside the boiler. (Tohoku Electric Power Company photograph)

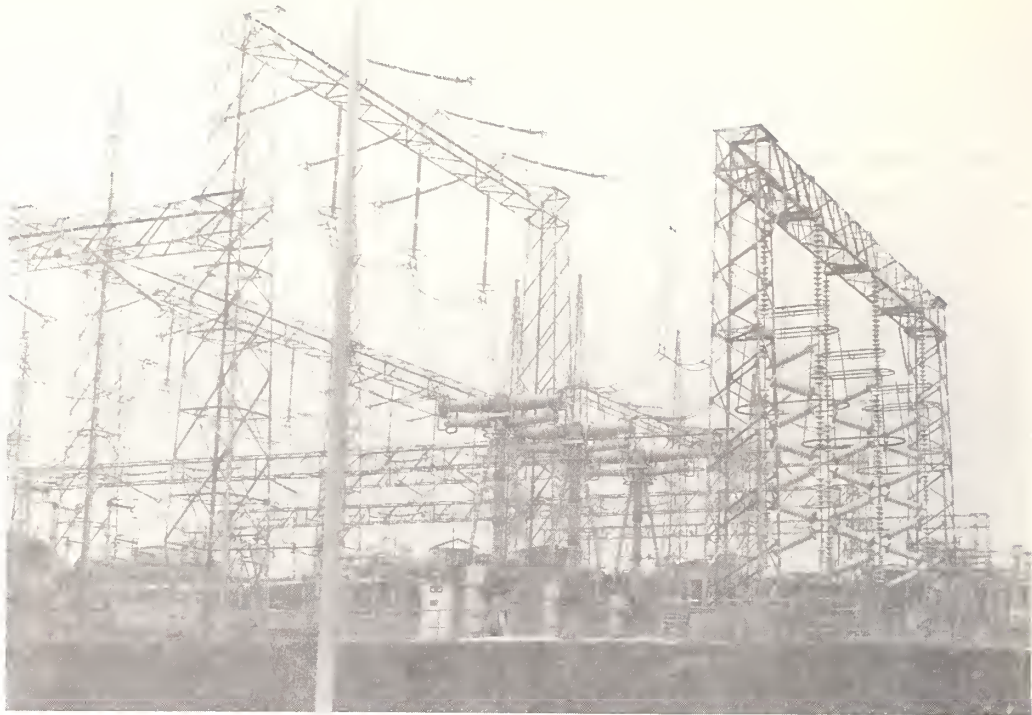
Figure 6.21 Sendai Substation, Izumi: a general view of a portion of one of the buses. Damage was not reported to these steel structures.

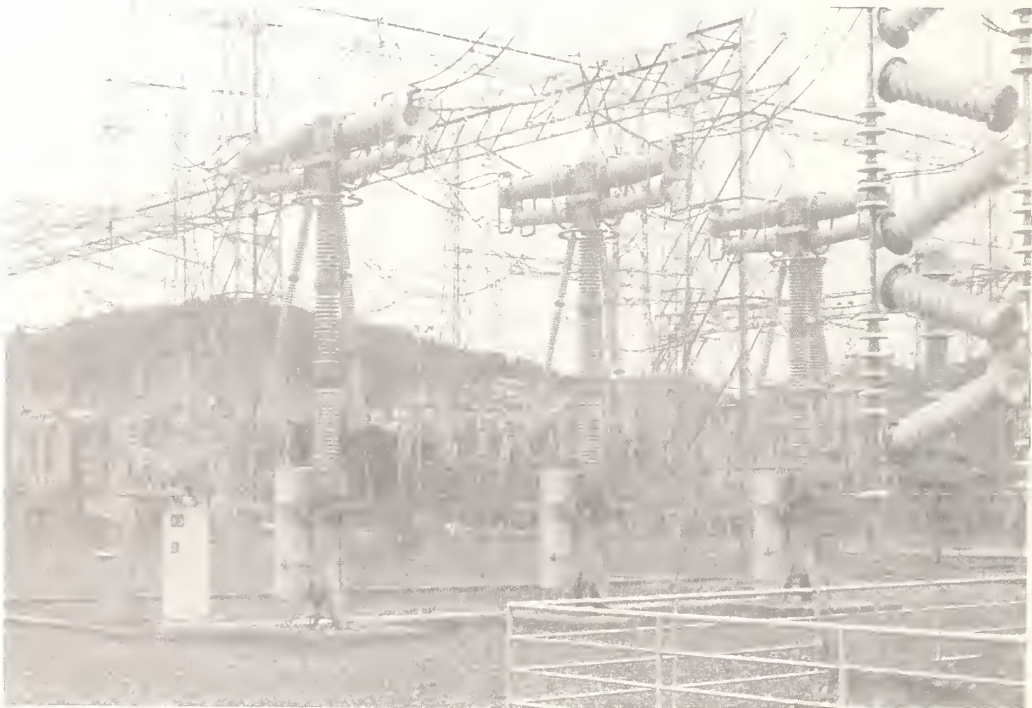
Figure 6.22 Sendai Substation, Izumi: three replaced 3-phase circuit breakers. This type of T-shaped circuit breaker suffered a high percentage of damage. Often the three symmetrical guides broke before the main stem. In all cases the structural steel supports appeared to be undamaged.
